Crash Inquiry Report

EA-3688 Bus / Car Collision near Shatial, District Kohistan

7th Feb, 2023

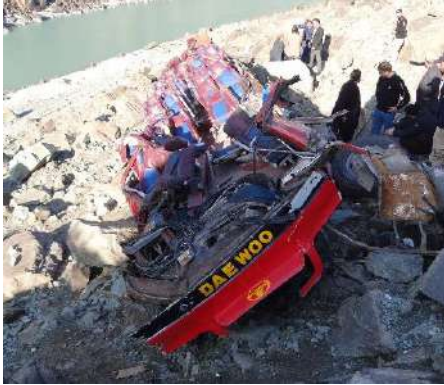
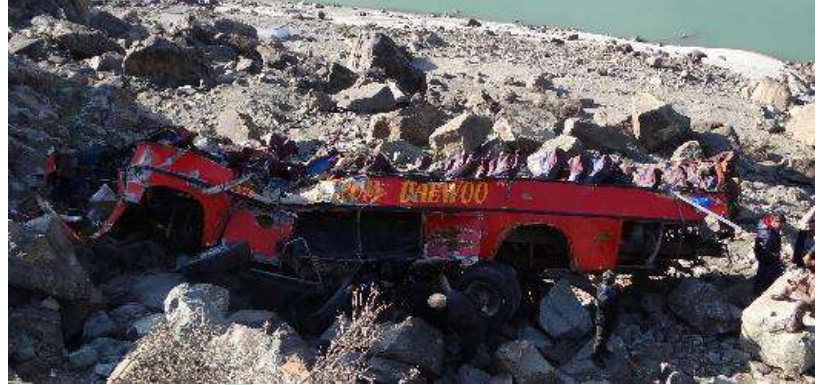
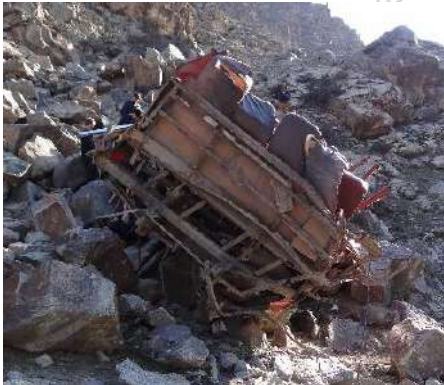
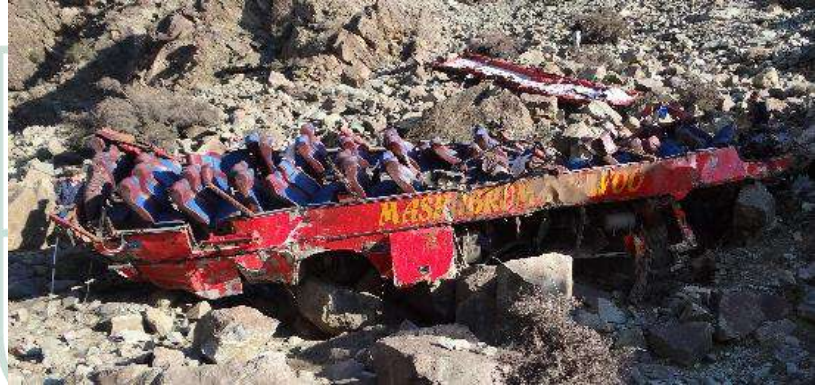
2.1 4 sides view of vehicle 1 (Bus)

- 2.11 The bus had a clear frontal offset impact on the front right corner. The front suspension was severely damaged due to the impact of the car (Vehicle 2) with the right tire of the Bus (Vehicle 1).
- 2.12 There was no impact on the bus from any of its sides during the collision. The sides were damaged during multiple rollovers
- 2.13 Roof of the bus was ripped off due to bus rolling down the cliff.
- 2.14 The body of the bus received extensive damage on all sides due to rolling down the cliff.
- 2.15 The details of Vehicle 1 (Bus) are as follows:

- 2.17 At the time of inspection, the front axle of the vehicle was present but dislodged from the chassis lying beside the damaged vehicle.
- 2.18 The rear axle was also dislodged from the chassis. All tires and axle components were intact. The car (vehicle 2) collided with the right front tire, damaging the hub. This led to the tire being stuck. The tire got dragged on as the bus veered towards the edge of the cliff, diving and rolling down the cliff.
- 2.19 The interior of the Cabin was extensively damaged as it rolled down the cliff. The Seats did not get dislodged from the floorboard.

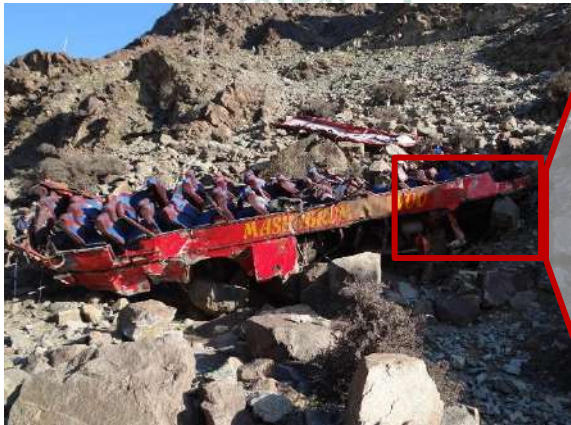
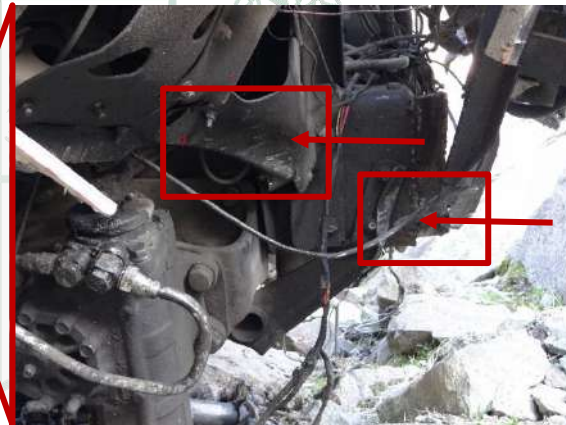
- 2.21 The only visible point of impact was on the right underside of the bus, the marks were indicative of a metal to metal contact. It was obvious the bus had collided on the right side frontal impact.

Metal marks of vehicle collision on right underside of bus

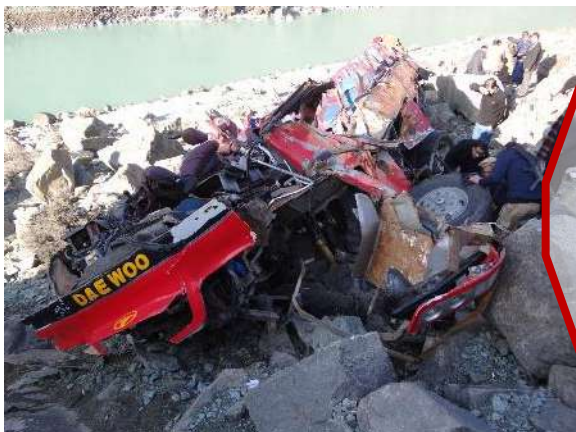
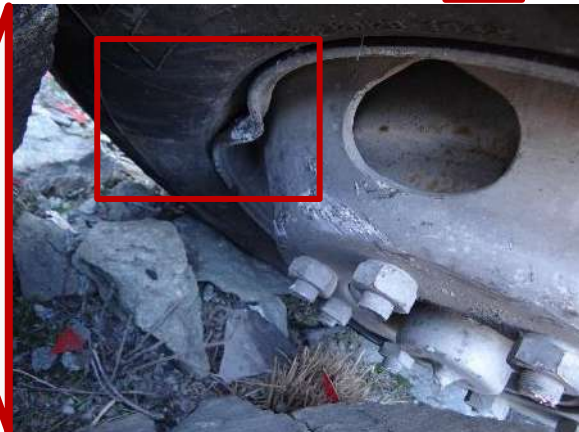
- 2.3.1 The left tire was the only location where a fragment of car paint was found. There was a distinct impact sign of the rim with white paint fragments.

White car paint marks on the bus front right tire

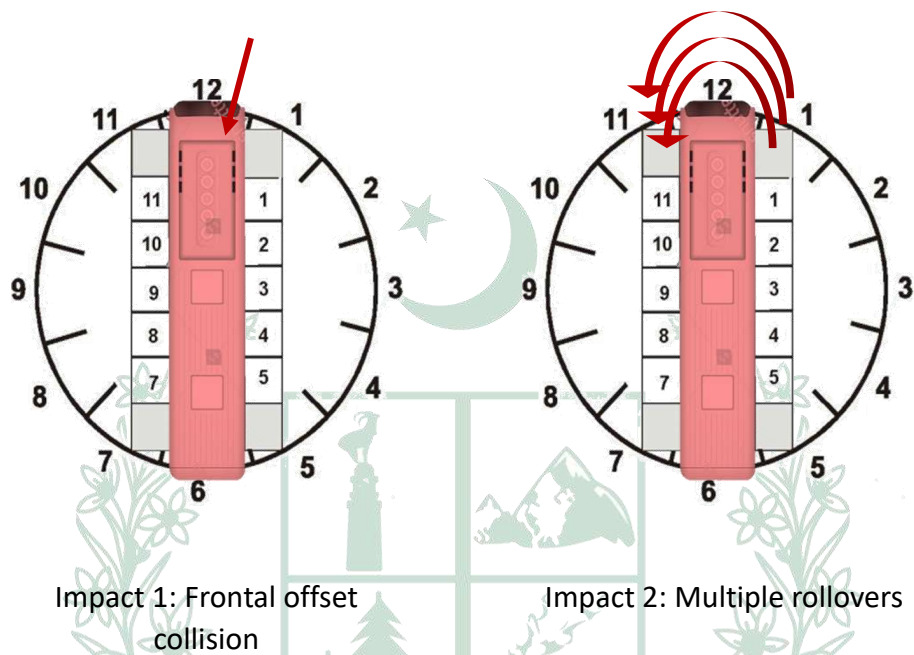
2.4 Clock Point Diagram

2.41 There are two clock point diagrams. The first clock point diagram denotes a frontal offset collision on around 12:30 of clock. The second clock point indicates a rollover.

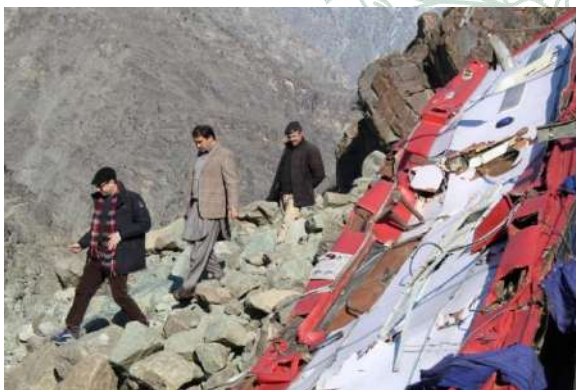
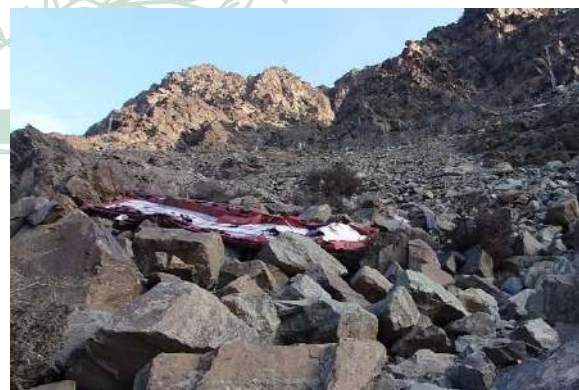
2.51 The roof of the bus got completely detached as it rolled over the rocks down the ravine. As the roof was completely detached, all the passengers were thrown outwards and smashed onto the rocks.

Roof of the bus

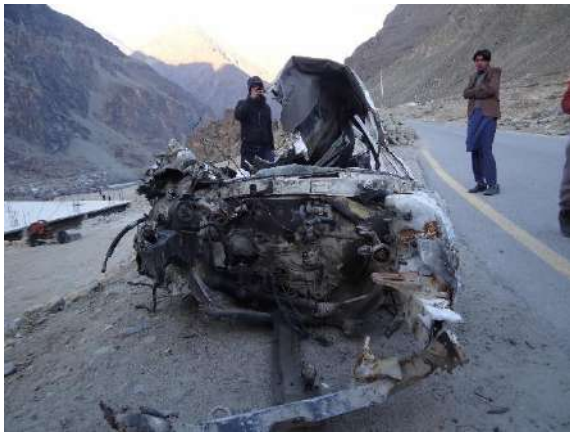
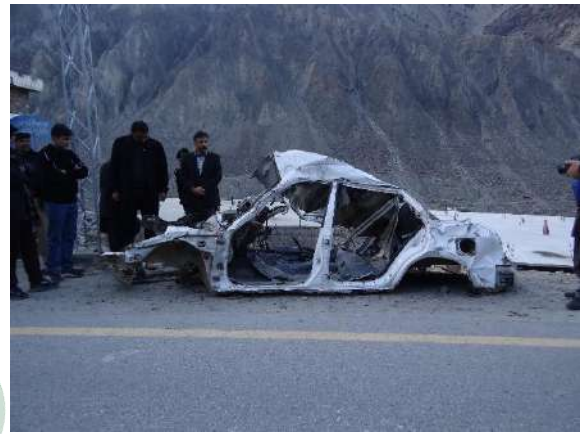
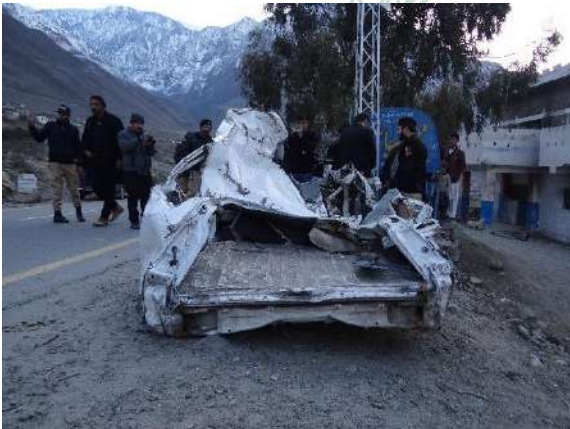
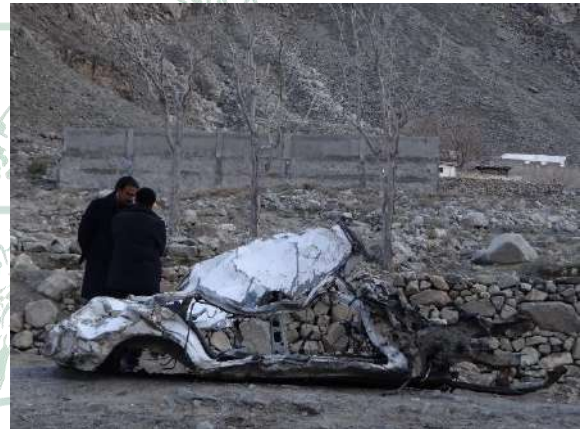
3.1 4 sides view of Vehicle 2 (Car)

- 3.11 The car had a clear frontal offset collision with Vehicle 1 on the right corner. The penetration depth of the impact was high.
- 3.12 The cabin roof was completely crushed downwards front to back on the right side during the collision with the Bus.
- 3.13 On the left side, the roof was crushed downward from the rear. The front part received only secondary damage from the collision.
- 3.14 The car bounced away from the bus and off the cliff post-collision with the right front tire.
- 3.15 The details of the Car are as follows:
 - Length: 13 feet 8 inches
 - Width: 5 feet 5 inches
 - Accident Impact: 8 feet approx.
- 3.16 At the time of inspection by ADCR team, the wreckage had been moved to Shatial police check post. The Suspension system along with the tires were missing from the wreckage.
- 3.17 Engine of the Car was detached from the wreckage and was found on the crash site.

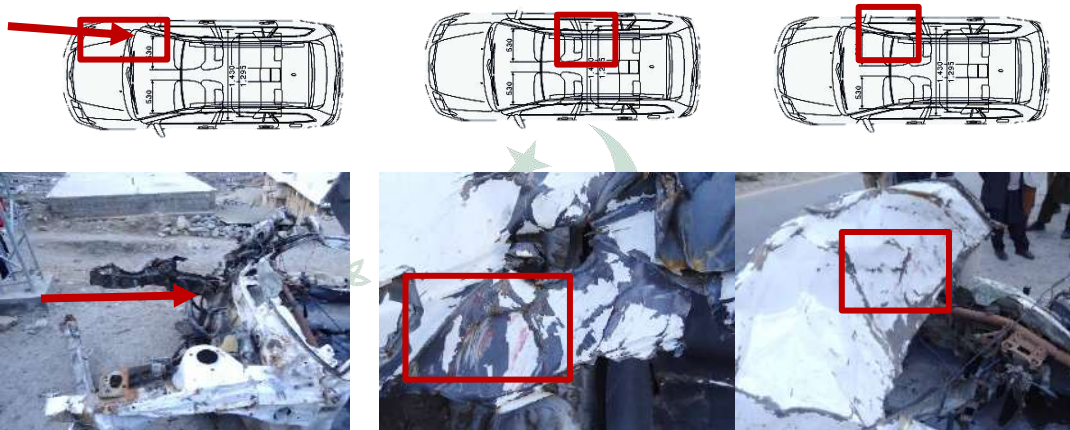
- 3.21 The vehicle firewall was bent backwards, indicating a large frontal force from the front.
- 3.22 Red pain fragments of the bus were found on the roof of the car near the A pillar and the B pillar on the driver side.
- 3.23 Paint fragments of the bus were also present on the Car firewall.

Principal Force direction

Bus paint marks on the passenger car visible on the roof left side.

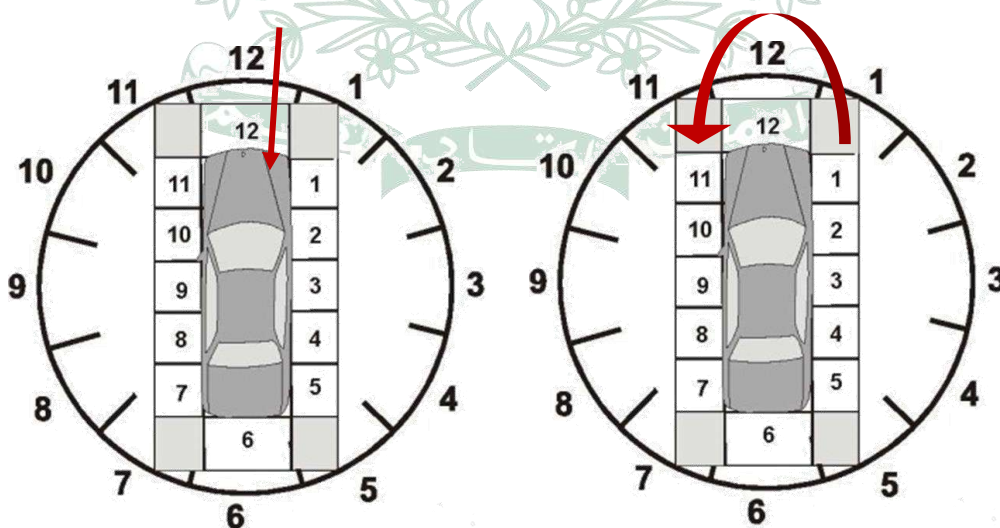
3.3 Clock Point Diagram

- 3.31 There are two clock point diagrams. The first clock point diagram denotes a frontal offset collision on around 12:30 of clock. The second clock point indicates a rollover.

Impact 1: Frontal offset collision

Impact 2: Multiple rollovers

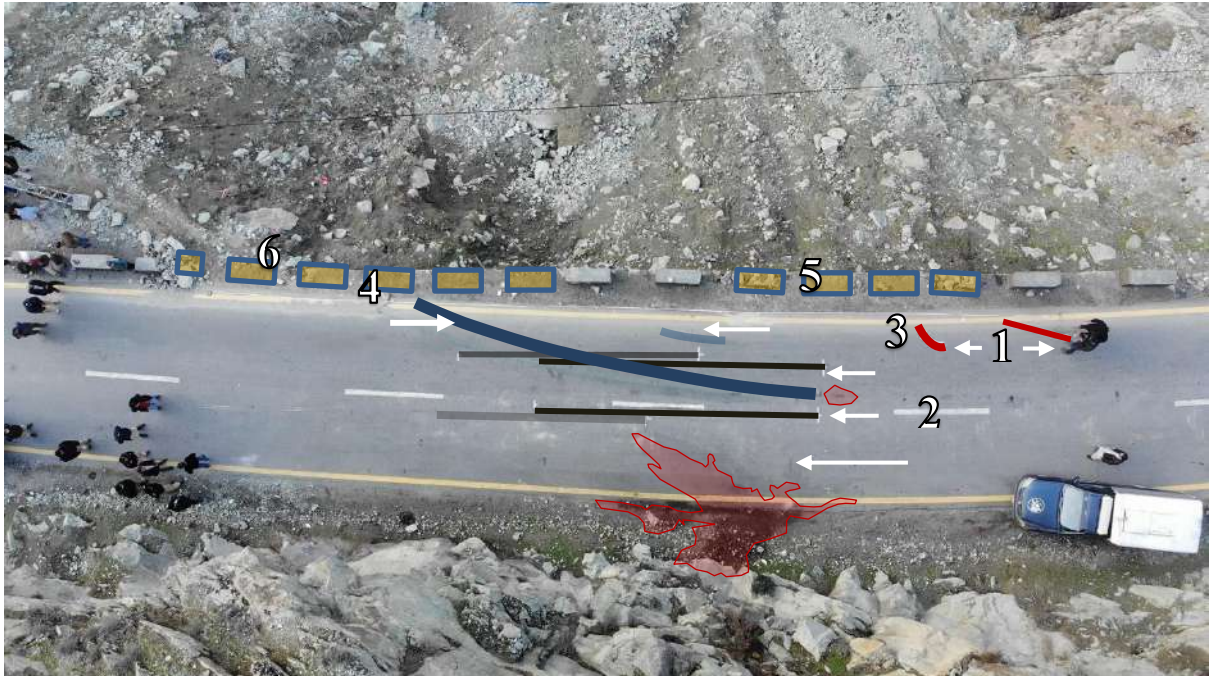
The following road marks were found at the crash point. Marks are numbered in the figure below and described and discussed below.

Mark #	Mark Identity
1	Metal Grooves on the road
2	Diesel + Oil Spillage
3	Skid Marks
4	Scuff Marks
5	Unknown Tire Marks
6	Broken Para Pit Walls

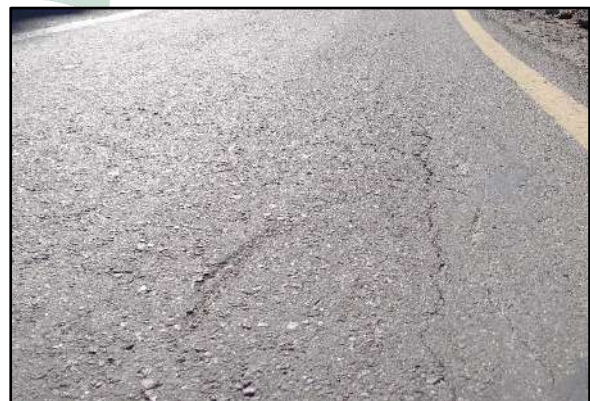
5.1 Metal Grooves

5.12 In mountainous roads, such marks are also sometimes caused by snowploughs and excavators when removing landslides and snow from the road.

5.13 These marks were found to be unrelated to the crash.

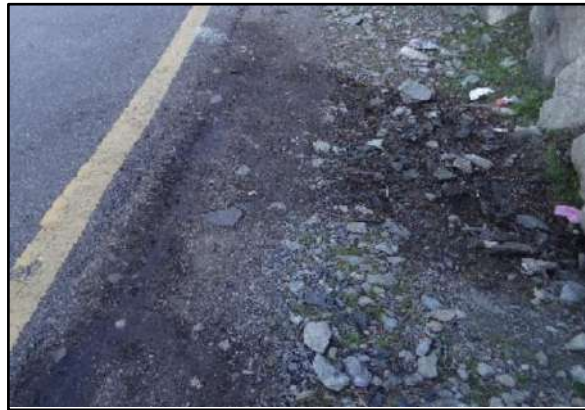
5.2 Diesel spill mark

5.21 The spill mark was fresh. the smell of diesel was also observed on the mark location on the day of observation. This mark may have been left later than the day of the crash.

5.22 This mark was not found on the trajectory of the any of the vehicles involved. Neither the passenger car nor the truck hit the cliff.

5.23 There were no paint fragments nor any. Impact marks on the cliff indicating that the vehicles had collided with the cliff.

5.24 This mark was likely left when the car was salvaged from the cliff and rested on the roadside three days after the crash.

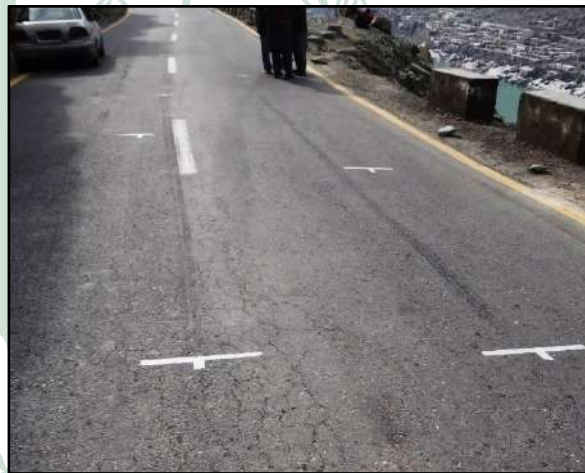
5.3 Skid marks

5.31 These were defined as skids of a non-ABS vehicle; The tires were about the size of regular passenger car tire.

5.32 Tire marks were measured to have a track width of about 147cm to 153cm about the size of a Toyota corolla Van 2001 model.

5.33 The length of the mark measured to be around 12.2 meters, Since the mark was 4 days old at the time of investigation, 20% additional length was added as compensation. The total length of car barking was estimated to be around 14.4 meters.

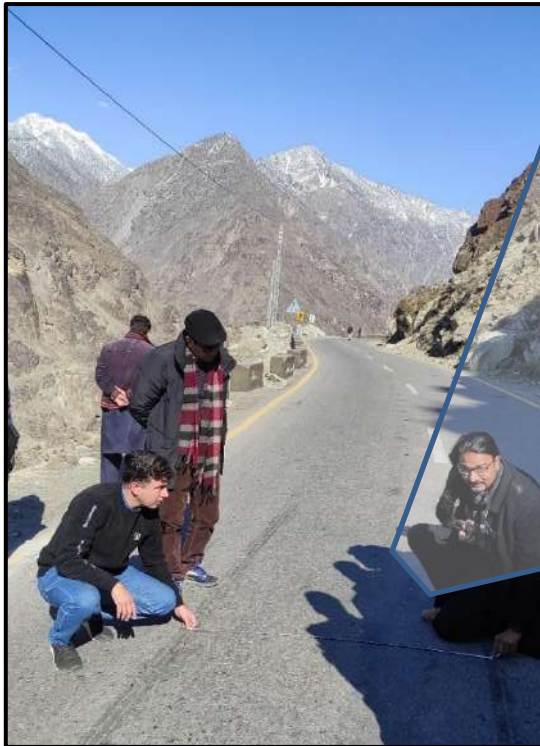
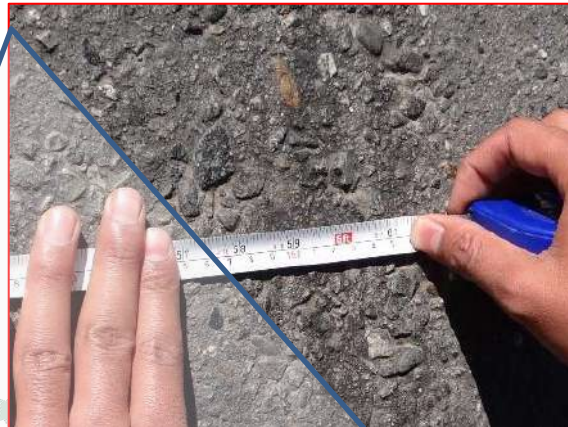
Measured Track Width
= 147- 153 cm

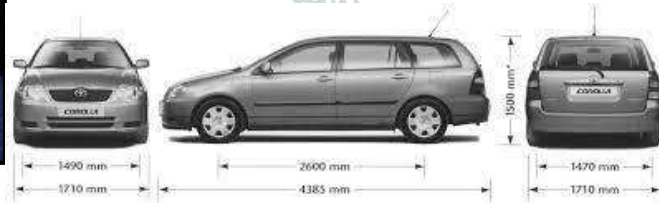
Toyota corolla Estate 2001 Track Width 148 cm

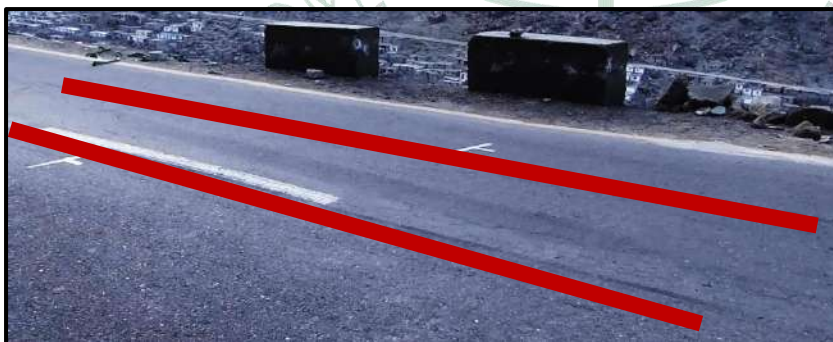
5.34 During heavy braking, the frontal tire marks are heavier than the rear tire marks due to load shifts. It was possible to identify the rear and the front mark set separately through examination.

Front tire skid marks

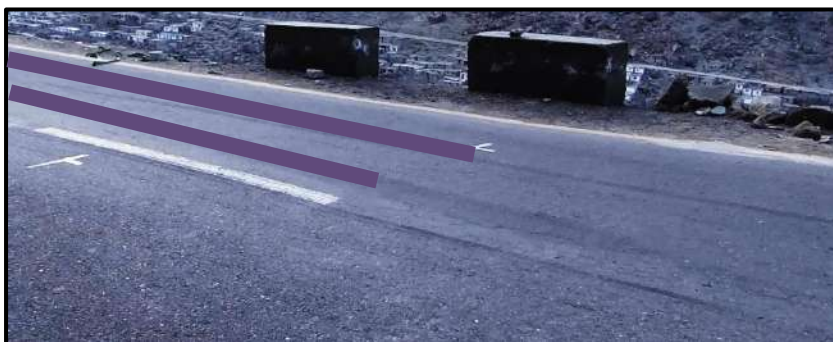
Rear tire skid marks

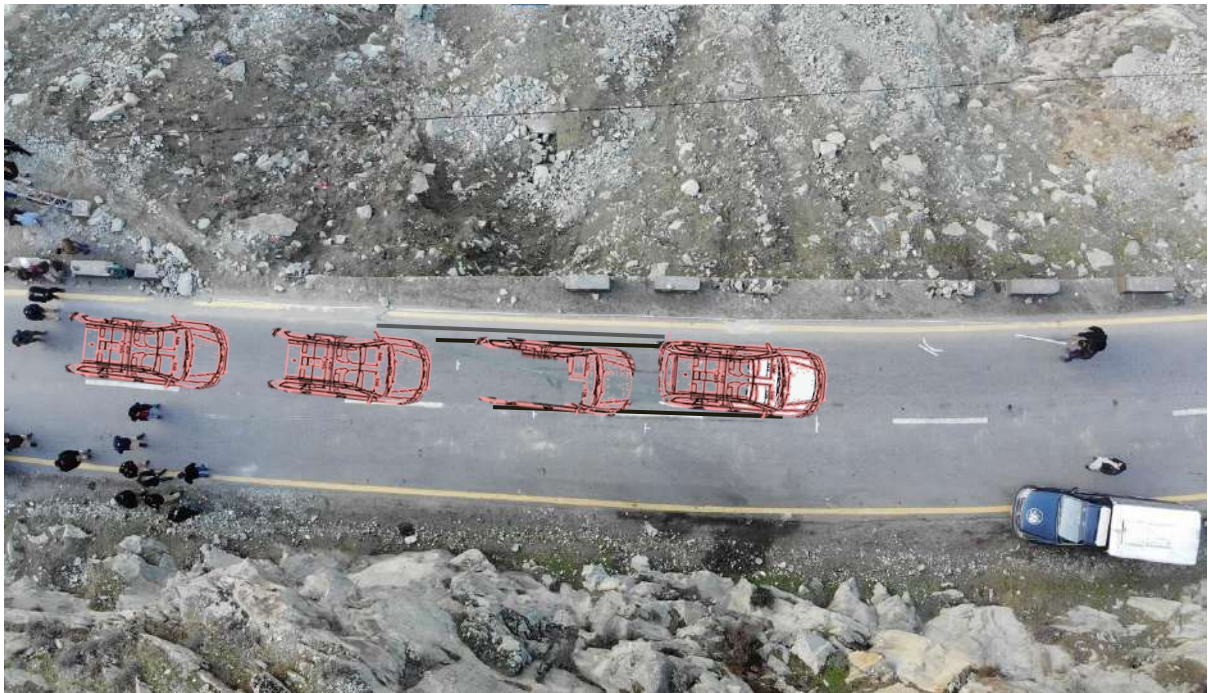
Path of Passenger Car prior to Impact.

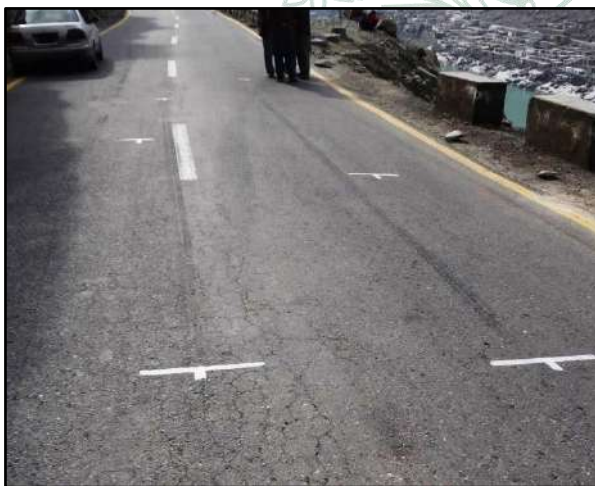
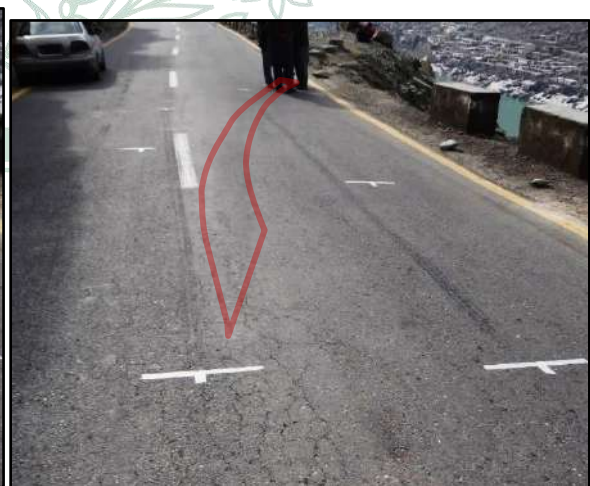
5.4 Scuff Marks

- 5.41 Scuff marks are not caused by braking, rather, they are caused by turning at high speed.
- 5.42 The mark was visible in the same zone as the skid marks, it was turning sharply towards the right (riverside)
- 5.43 The mark appeared to be of a large tire about as old as the skids. This mark may have been left by the bus frontal tire after collision. The bus lost control and turned towards the right due to brake or steering rack and pinion breakage during impact.

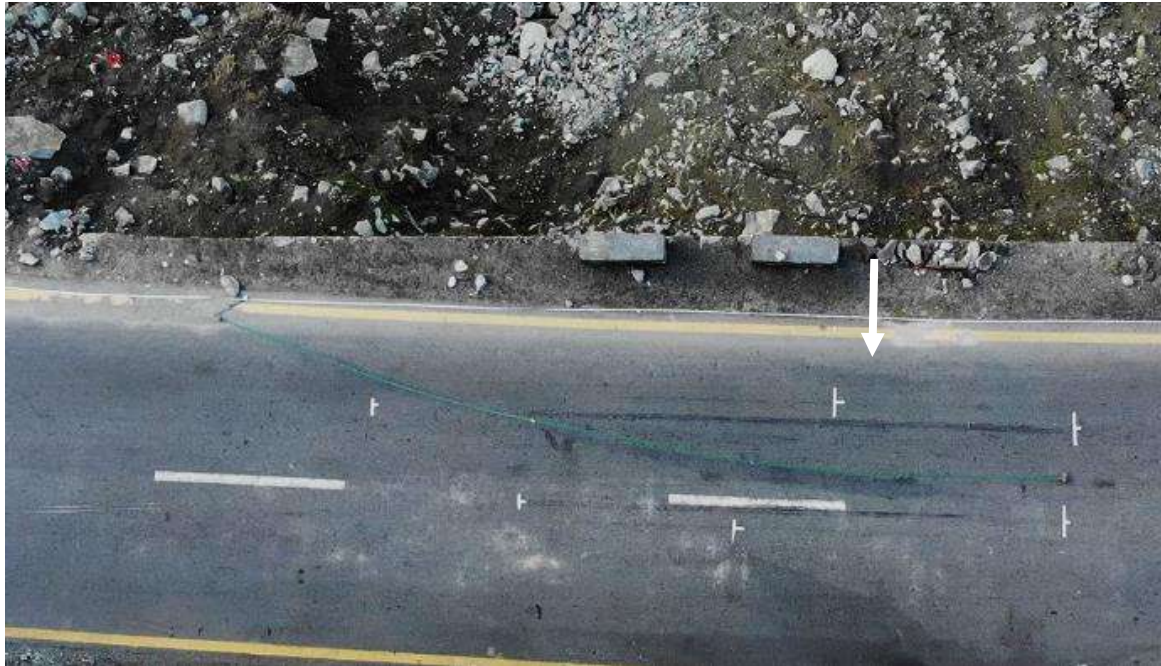
5.5 *Unknown tire mark*

5.51 An unknown tire mark was found on the left side (river side) of the scuff mark. This mark was later discarded as not being relevant to the inquiry. It may be possible that one of the emergency vehicles during search and rescue operations left this mark as the bus trajectory did not tread on this side.

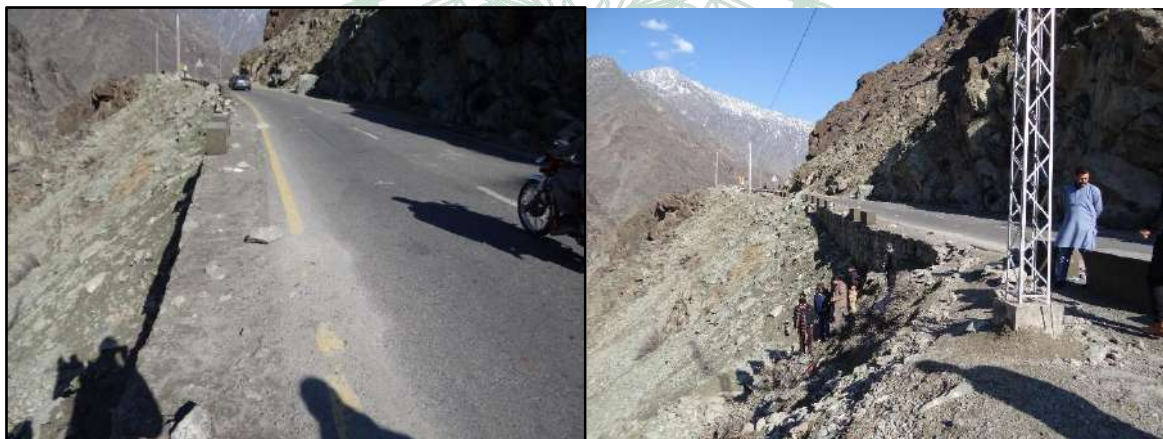
5.6 *Broken Para Pit Walls*

5.61 It was evident that para pit walls were crushed as both vehicles were off tracked. It can also be proven by the fact that only the middle para pit walls were present, the walls where the vehicles off tracked were found to be missing.

The issue of Substandard para pit walls and non-provision of guard rails must also formally be undertaken by the Government of Gilgit Baltistan with the federal Government of Pakistan. They should also conduct a formal road safety Audit of the Highways within GB.

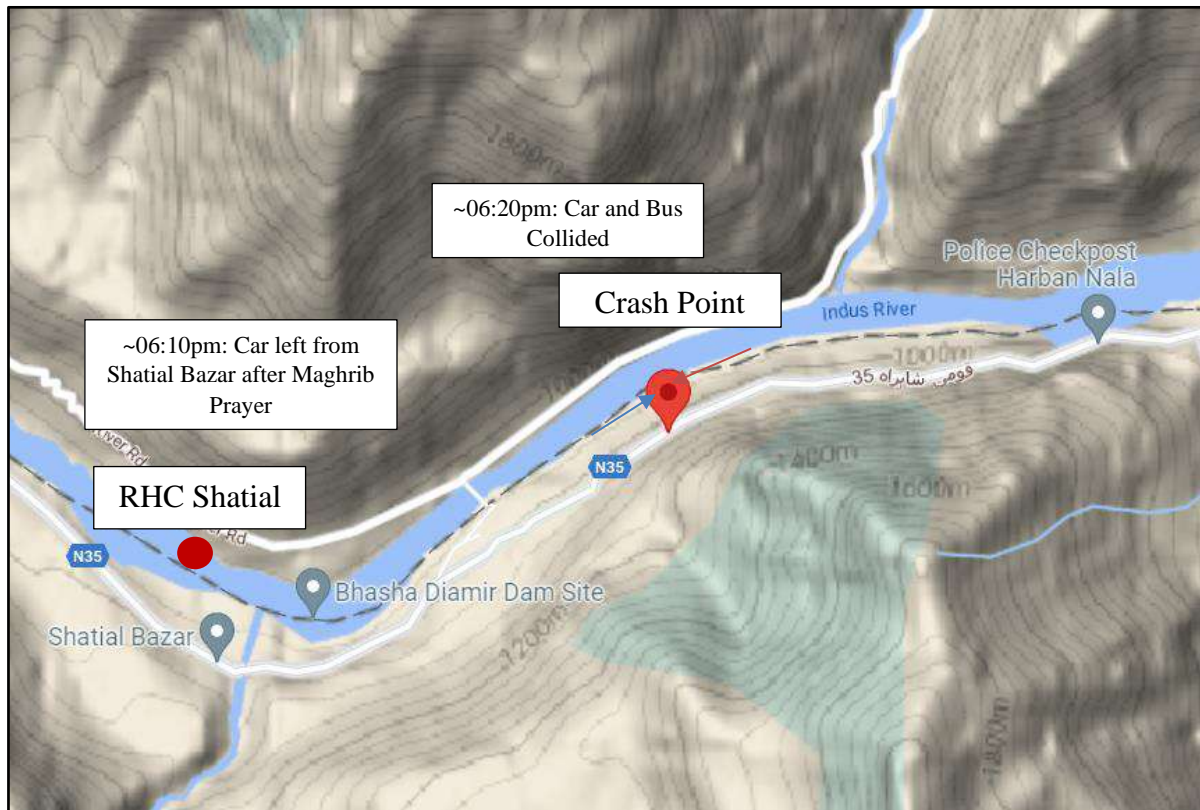
6.11 The crash occurred on N35 Highway between the Shatiyal Police Check post (KPK) and Harban Nala Check post (KPK)

6.12 Road was the N-35 national highway. It is a carpeted highway going through a rugged mountainous terrain. It was an outward cross-sloped road; at the point of collision the cross slope was reaching about 5%

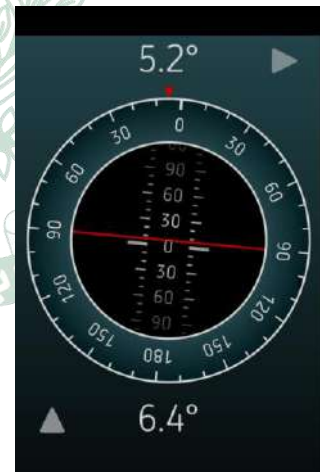
6.17 The road N-35 at the point of the crash was at the elevation of 1050m altitude.

- 6.18 The maintenance road conditions were satisfactory, the carpeting was acceptable, the road borders were visible, and the median line was also clearly marked and visible. Para pit walls were also present along the sides of the road and the point of collision.

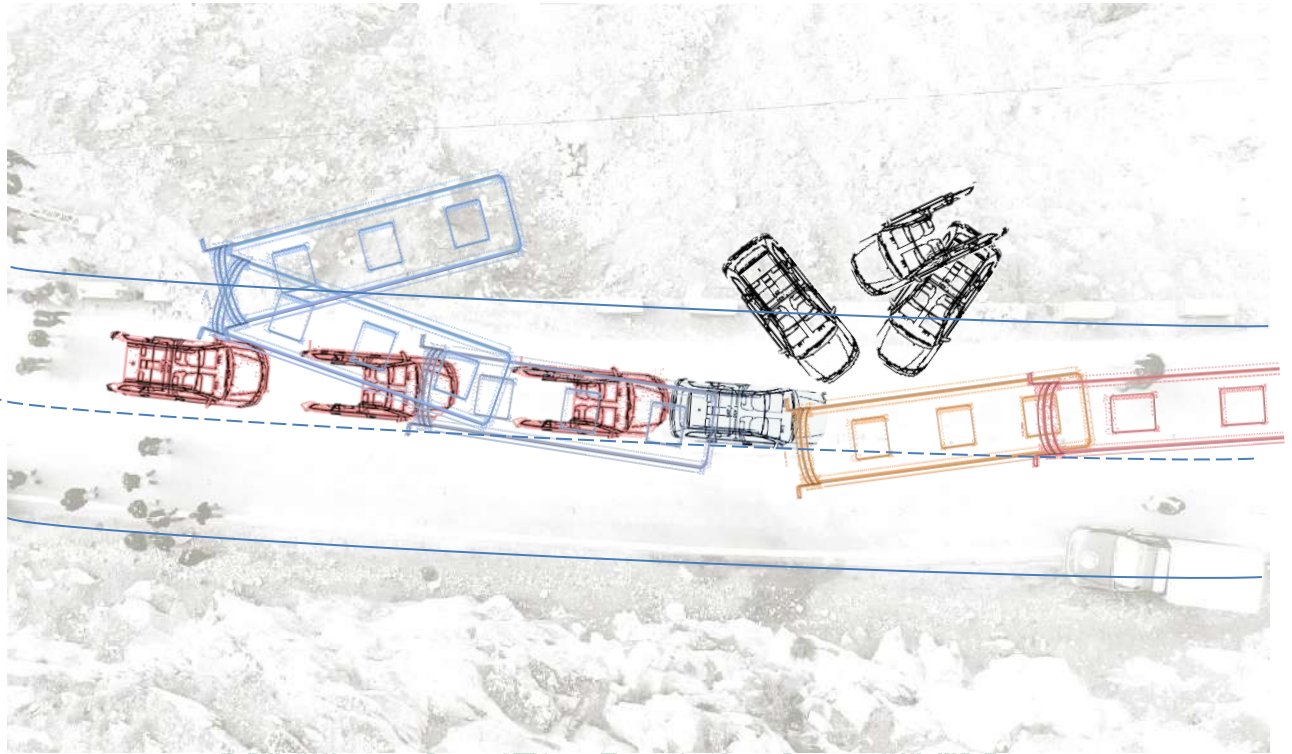
12.1 Collision Diagram

Collision Diagram

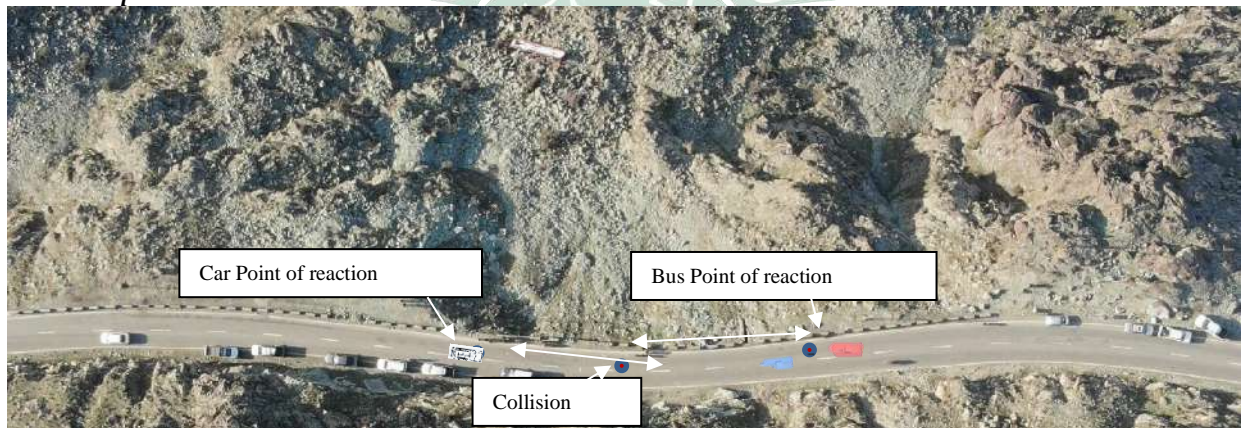
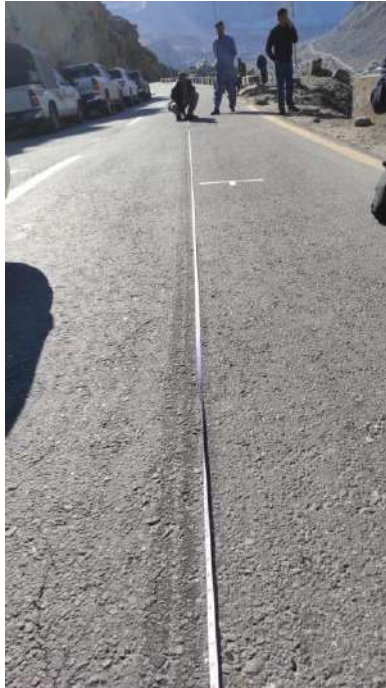
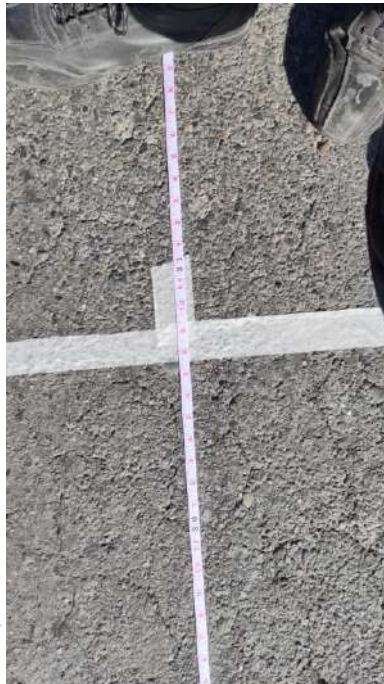
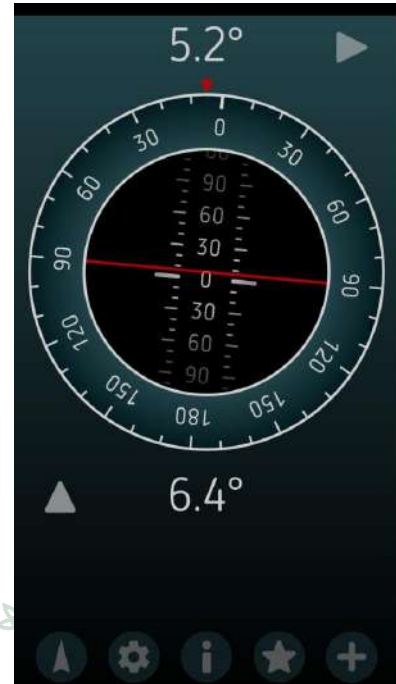
12.2 Speed Calculations

Length of mark 12m

Length of mark with 20 percent. = $12 * 1.2 = 14.4$ meters

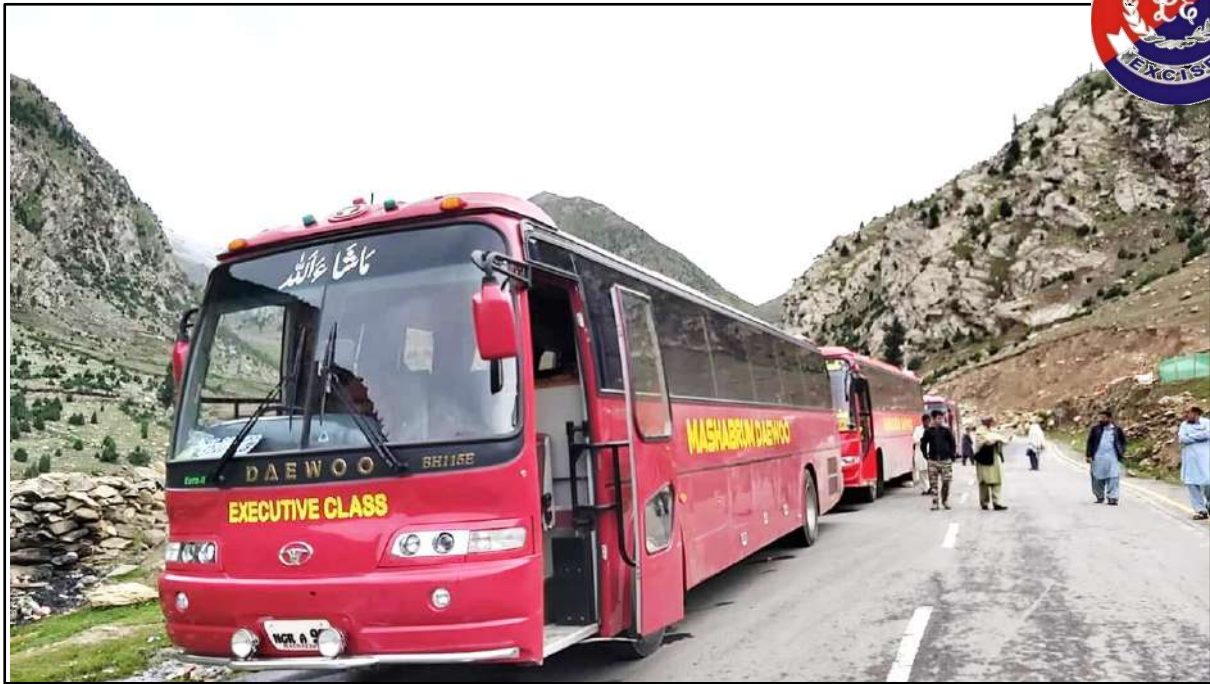
Speed Limit Signs and Concave mirrors

The National Highway Authority, Islamabad should be officially contacted for the provision of concave mirrors along each curve of the National Highway. NHA should also be asked to post realistic speed limit signs on the road.

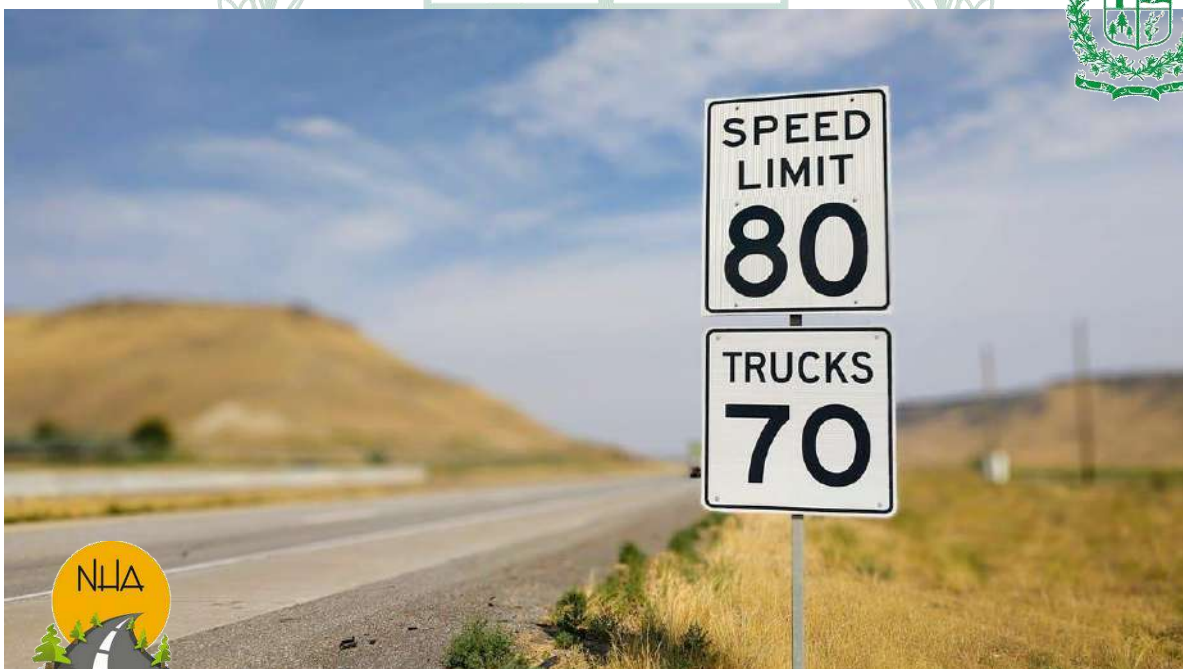
There is a huge ambiguity about speed limits on this road. When NHA was asked in writing about the speed limits on KKH by the commissioner's office, they denoted a speed limit of 40kph, which is highly impractical. When the Superintendent of Police was asked about the speed limits, they denoted 70kmph as the speed limit. **No speed limit signs are present on the road.**

A small survey project can be done by the GB government which can assign the different speed limits in different zones. (Lower speed in areas with sharp turns and a higher speed limit on relatively flat areas. The project can also chart out where the speed limit signs have to be placed along the road for effective speed management.
