## **Crash Inquiry Report**

LES-8831 Bus Accident near Hatushi Shong Yashukal (Near Chilas) District Diamer

3<sup>rd</sup> May 2024

(Submitted by Govt of Gilgit Baltistan's notified Inquiry Committee on the incident)

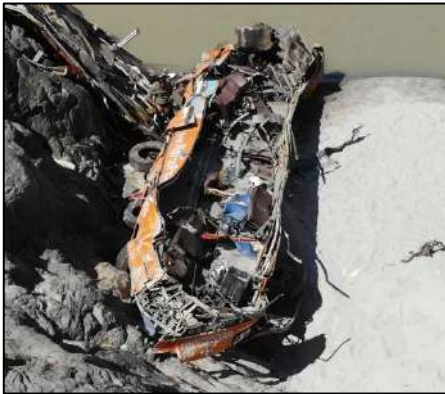
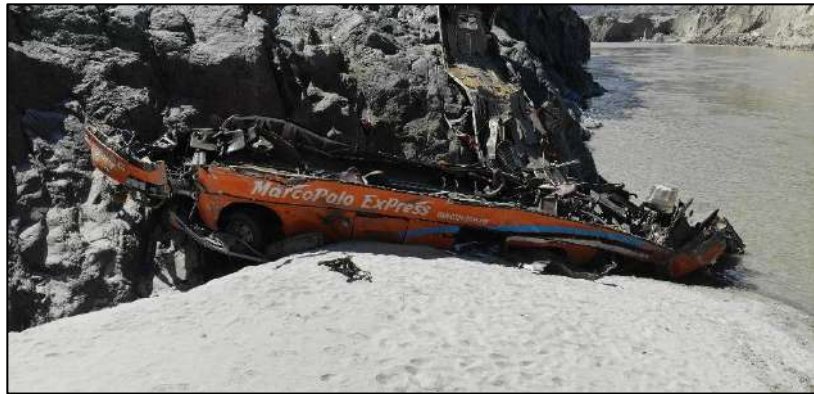
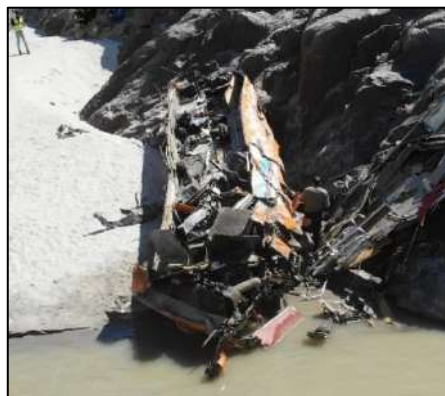
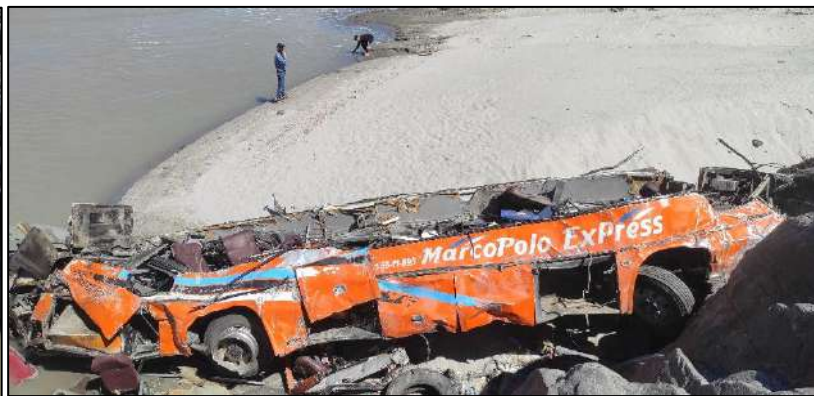
- 5.1.1 There was no sign of frontal collision of the bus or any other type of major collision with any other vehicle or the road barriers.
- 5.1.2 There were no observable marks of any side collision with any other vehicle. Any minor collisions with any vehicle could not be ruled out at this stage due to the extensive damage suffered by the bus during the cliff fall.

- 5.1.3 Roof of the bus was ripped off due to bus rolling down the cliff. The body of the bus received extensive damage on all sides due to rolling down the cliff.

- 5.1.4 Seats of the bus got detached from the floor and some were found as a debris on the rocks. The bus fabrication process was non standardized.
- 5.1.5 At the time of inspection, both the axles of the vehicle were present although tires of the rear axle got off the wheels while rolling down the cliff. The right wheel of the rear duplex axle was found cracked and severely damaged.

- 5.1.6 The interior of the Cabin was extensively damaged as it rolled down the cliff. The frontal area and the driver controls were not present, it was a rear engine bus.

5.1.7 All damages were likely low speed damages, (under 25kmph) such as a cliff fall of 5m-10m at a roll max). There was no observable high speed collision damage of a colliding vehicle (about 60/70kmph type)

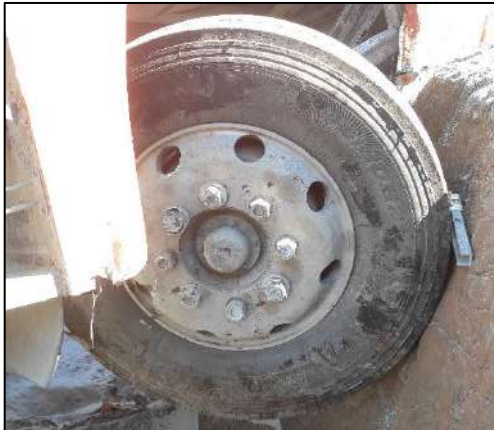
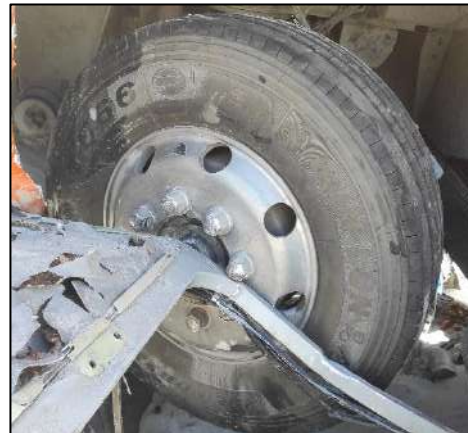
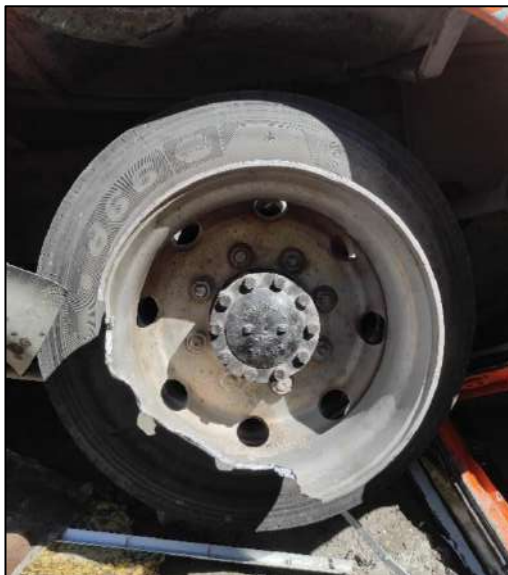
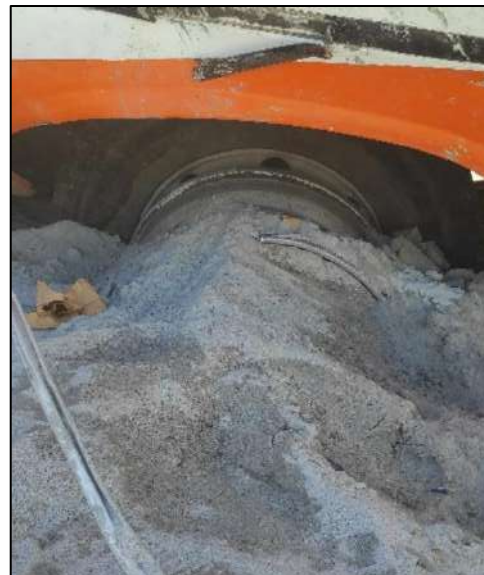
- 5.2.1 Tires of the front axle of the bus were found in good condition. They were relatively new with a tread depth of 8 to 10 mm and found in perfect working condition.
- 5.2.2 Outer Tires of the rear duplex axle of the bus got dismantled while the bus had multiple roll overs. Inner tires of the axle wheels were found inflated and in good conditions after the crash.
- 5.2.3 Outer right wheel of the rear axle got hit by boulder and cracked causing a severe side wall damage to the tire shown below.

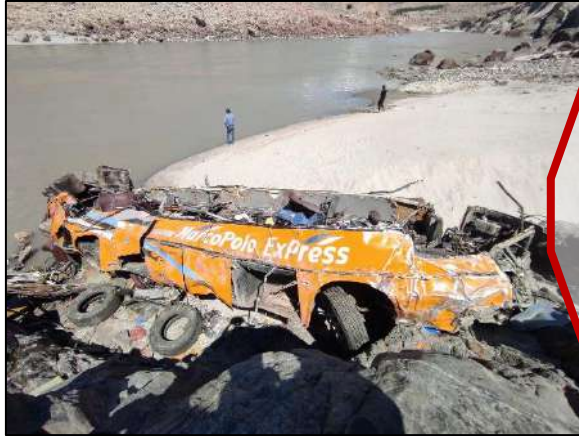
Cracked rim of the bus rear outer right wheel and Side wall damage on the tire

- No pre-crash failure of the tires was found in investigation of the crashed bus.
- Front wheels were found inflated and had no sign of tread wear or damage. The inner tires of the rear duplex axle were found inflated and had no sign of tread wear or damage however the outer wheels of this axle were found severely damaged.
- Skid marks on the road shows clear striations on the road which proved that the tires were inflated while braking.
- Post-crash damage on the rear right tire was observed. However, this type of damage is not the cause of the crash but a consequence.

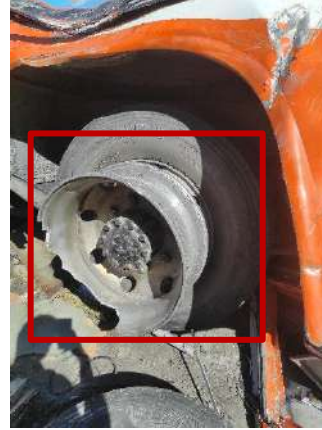
Side-wall damage such as this occurs 'During the crash', not 'Before the Crash' thereby causing it.

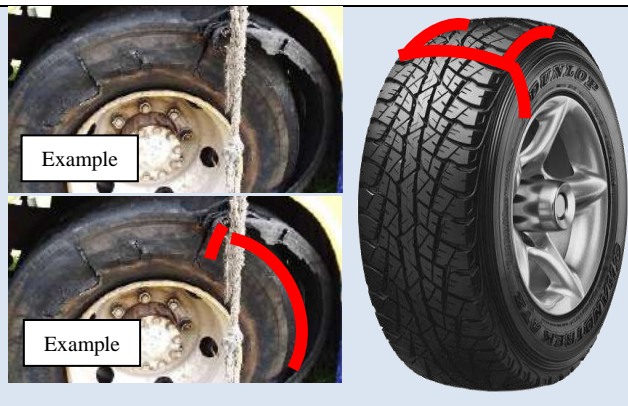
In case a tire burst causes the crash, the burst occurs in a "Global Mode" with a tear starting axially and then moving circumferentially along the perimeter of the tire as in the case shown right. This was not the case in this crash.

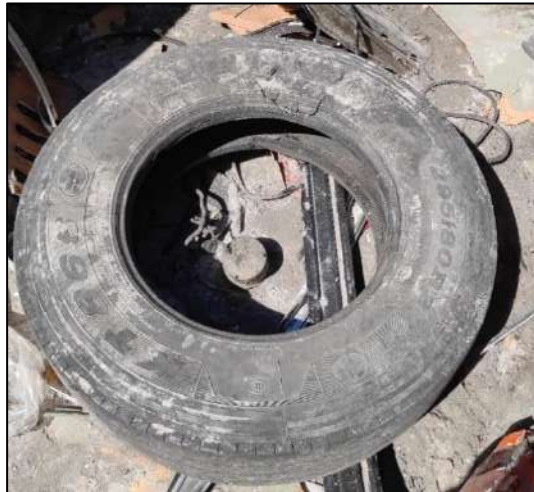
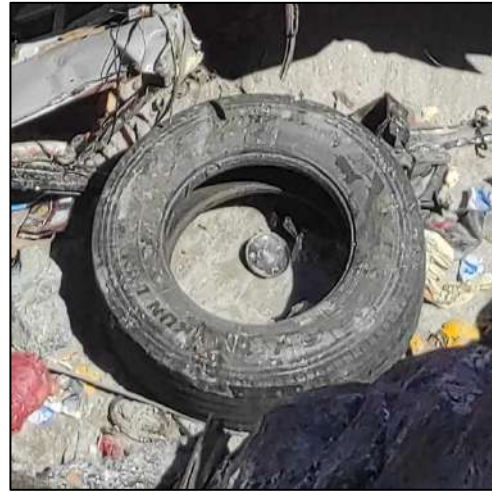
5.2.4 Two dismantled tires were found lying beside the bus body. Rear left tire had no observable damage. Tires had acceptable tread depth.

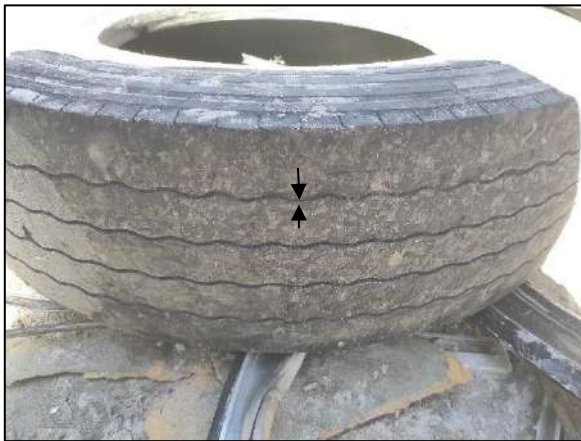
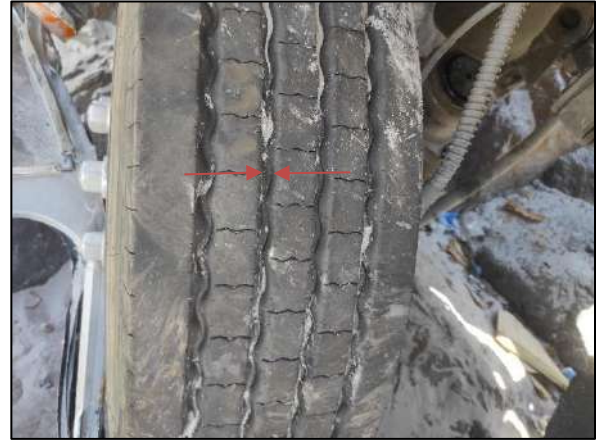
**Tire Tread**  
Acceptable Tread Depth

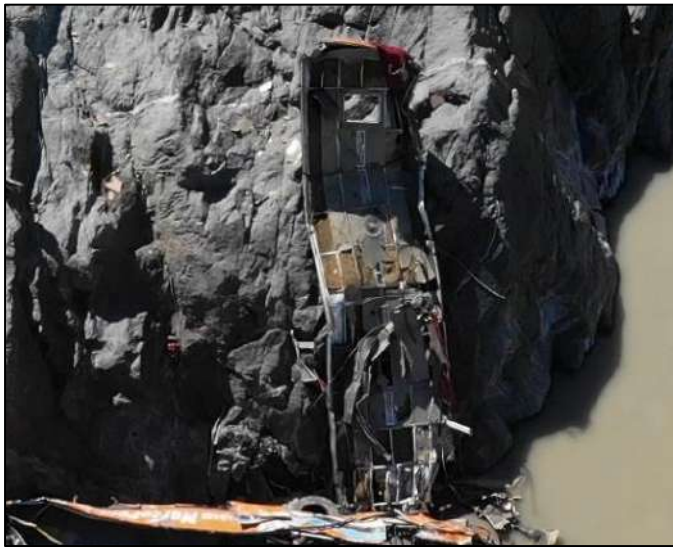
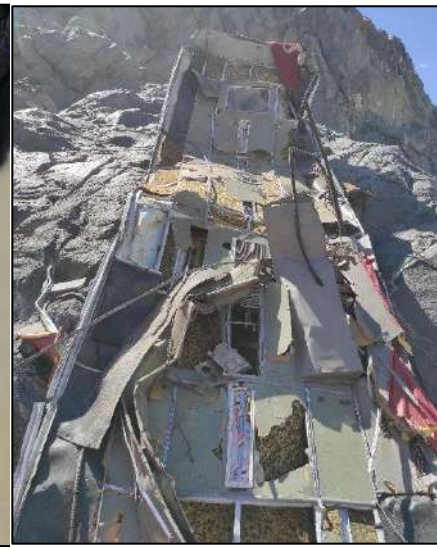
- 5.3.1 The roof of the bus got completely detached as it rolled over the rocks down the ravine. As the roof was completely detached, most of the passengers were thrown outwards and smashed onto the rocks.
- 5.3.2 The roof was very weak and not up to any vehicle design safety standards. If the roof of the bus was made up to UNECE R66 regulations, the majority of lives would have been saved.

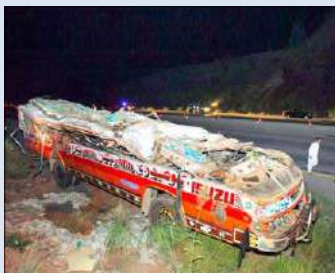
School bus rollover on 11 sept 2011 on M2 near Kalar-Kahar which killed 37 schoolchildren.

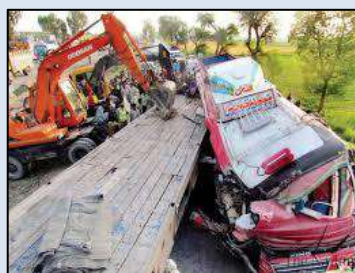
Trailer/bus collision on April 20, 2014, on N-5 near Sukkur which killed 44 passengers.

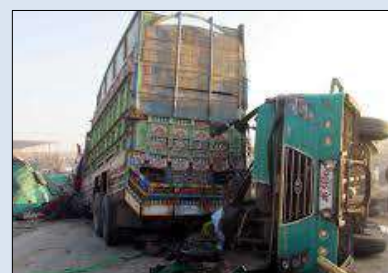
Bus/Truck Collision near Theri bypass, Khairpur on 11th Nov 2014 which killed 57 passengers

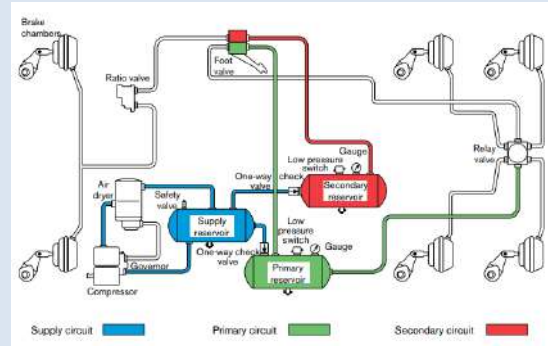
When a brake application is made, air is drawn from the primary reservoir (green) through the foot valve and is passed on to the relay valve, which delivers air from the primary reservoir to the rear brake chambers. At the same time, air is also drawn from the secondary reservoir (red), passes through the foot valve and is passed on to the front brake chambers. If there is an air loss in either circuit, the other circuit will continue to operate independently. Unless air is lost in both circuits, the vehicle will continue to brake. The primary and secondary circuits are equipped with low-pressure warning devices and pressure gauges. Modern air brake systems are very reliable with multiple fail safe redundancies. Sudden and complete loss of brake failure does not occur in such systems.

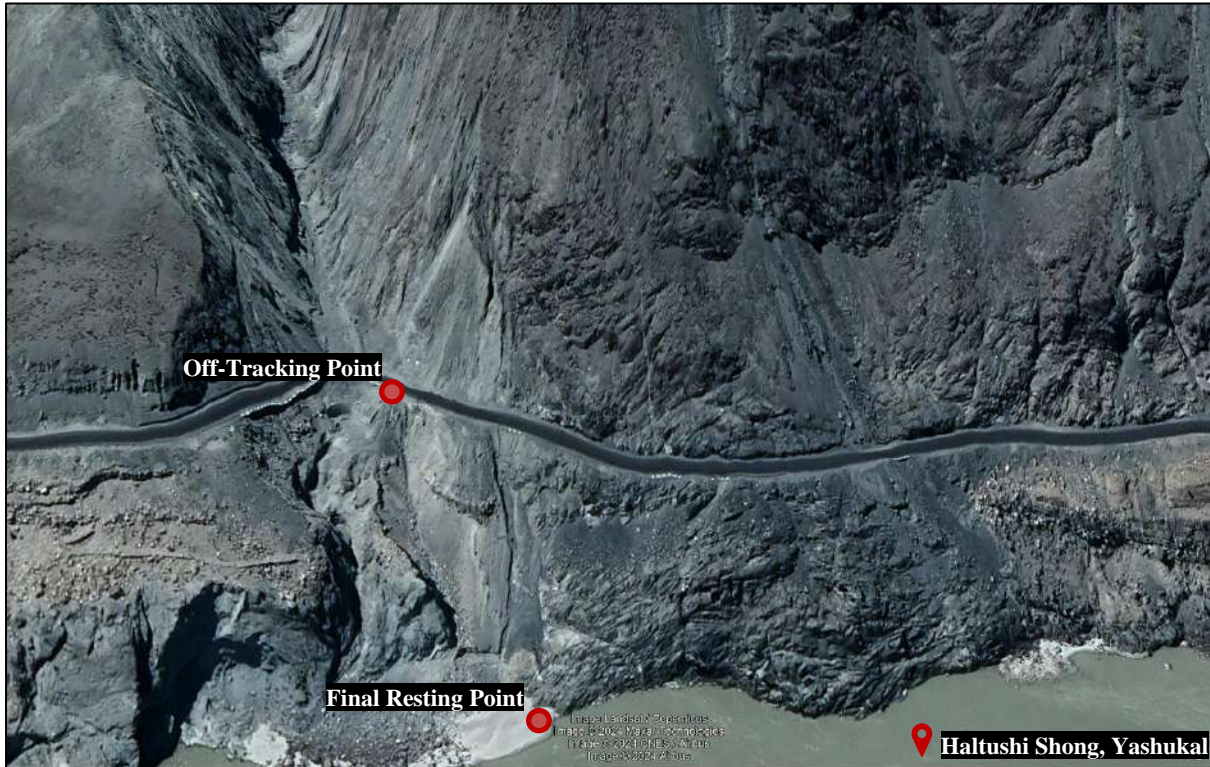
The crash occurred on the main Karakorum Highway N35 about 10 Kilo meters ahead of Chilas Market, KKH.

The road is two lane mountainous dual lane road for two-way traffic. This patch of the road has an average gradient of around 2 percent, with the maximum gradient in this area around

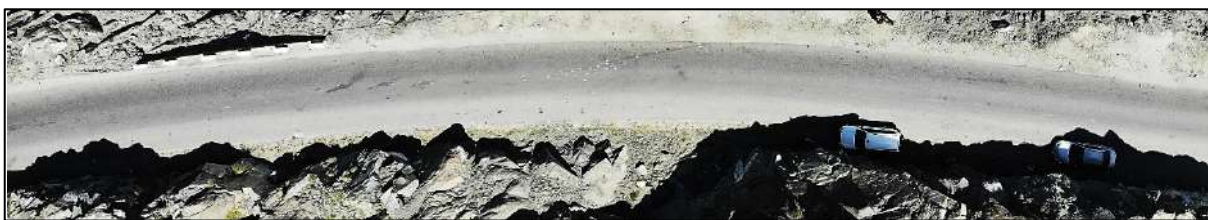
5percent. The road has multiple blind corners and has a major cliff-fall hazard which is unprotected.

6.1.1 The road section did not have any lane and road markings or delineation as per the AASTOO standards and also likely as per NHA approved consultant plans for road rehabilitation. Lack of lane markings cause drivers to tend to drive in the centre of the road thereby causing frequent frontal offset collisions between two-way traffic.

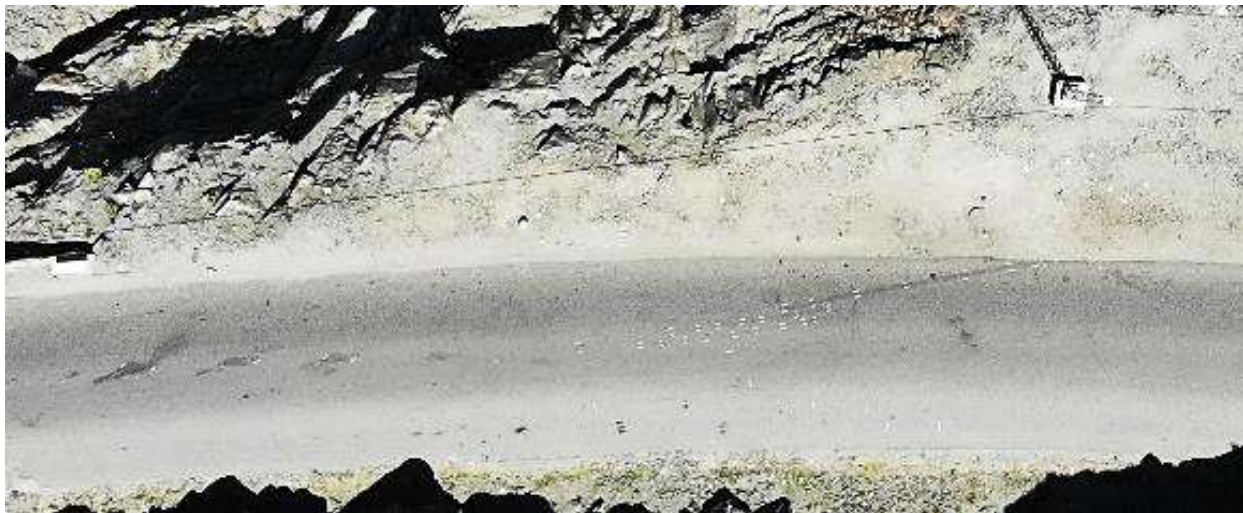
The following road marks were found at the crash point. Marks are numbered in the figure

Mark #	Mark Identity
1	Skid Mark
2	Skid Marks
3	Spillage tire overrun marks
4	Oil Spillage
5	Unknown Skid Marks
6	Unknown Scuff Marks

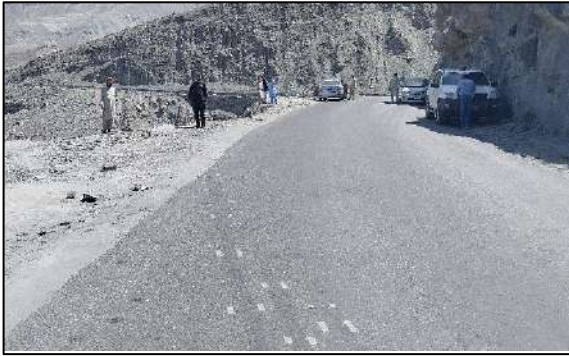
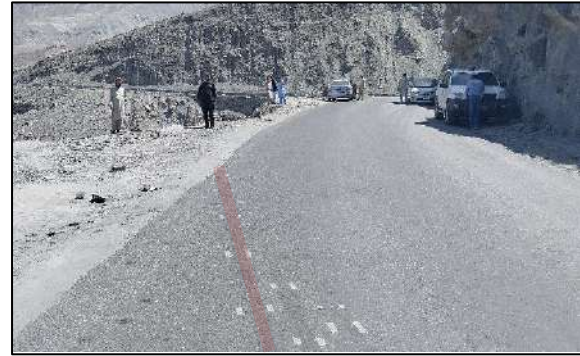
- 6.3.1 This skid mark had clear striation mark and on measuring the width proved it to be of a heavy vehicle. Mark was imprinted right before the track ends, leading toward the cliff.
- 6.3.2 Length of this skid mark was 8.635m.
- 6.3.3 Skid mark is continuous and lengthy which shows that the vehicle did not have any ABS braking system.
- 6.3.4 The mark had clear grooves visible indicating that the tire was pointed directly towards the cliff and not steered towards the left. **The direction of the steering wheel of the bus at the time of braking was towards the cliff.** No emergency steering was done before the crash.

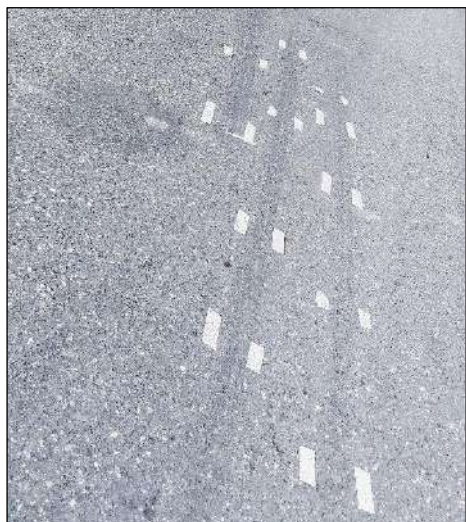
- 6.4.1. Two skid marks were observed starting right at the start of the mark#1. This skid marks are continuous which shows that the vehicle did not have ABS braking system.
- 6.4.2 The striations of the skid marks explain the sudden braking of the vehicle.
- 6.4.3 The length of skid mark#1 was 5.6m and skid mark 2 was 6.6m.
- 6.4.4 These marks were of a larger vehicle having duplex axle on the rear.
- 6.4.5 This indicated that the rear wheel had functional braking, the wheels were also not deflated so tire burst was not a cause, and the wheel hubs of the bus did not have any mechanical breakage.

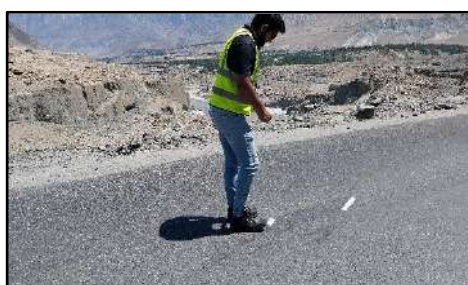
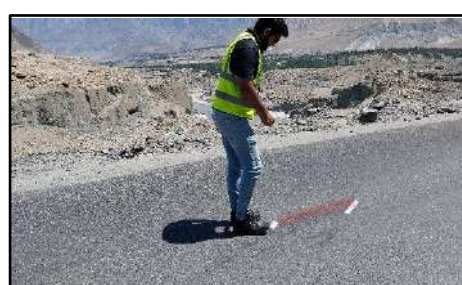
- 6.5.1 These marks were due to over running of vehicles on the spillage and not due to braking.
- 6.5.2 On measuring the distance between each mark was equidistant to one another.
- 6.5.3 This fact was further proved by measuring the circumference of a HTV vehicle. These marks were unrelated to the crash and left by some other vehicle.

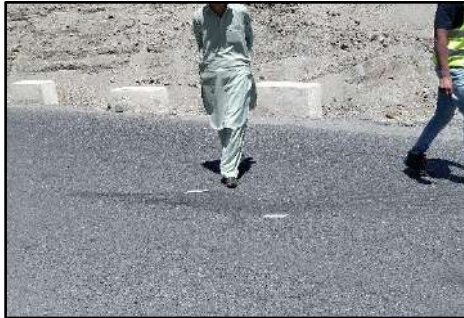
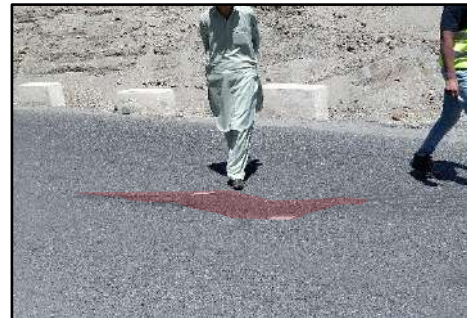
6.6.1. Fluid spillage which could be of either engine oil or diesel. Likely unrelated / inconsequential to the crash causation.

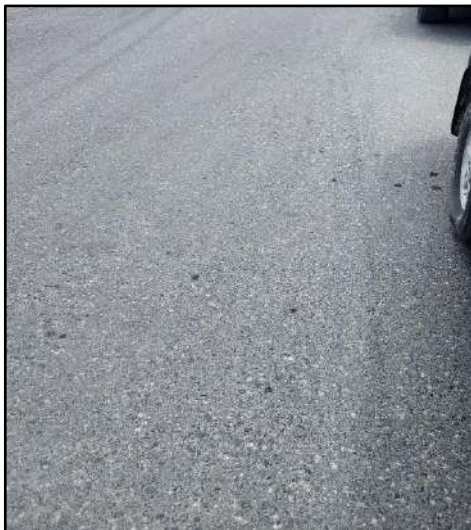
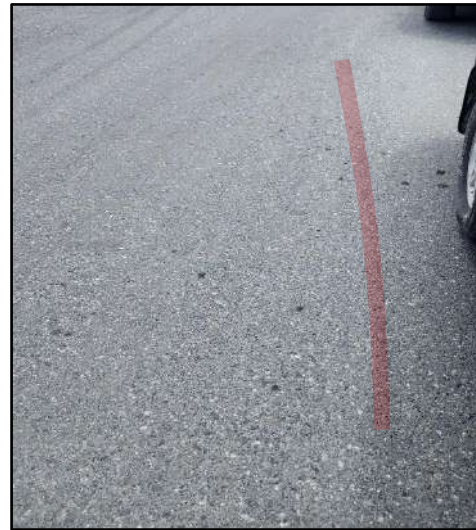
6.7.1 This mark was also observed on the median of the road near crash site on the right of mark 1 and 2.

6.7.2 The shape of this mark is however different from mark 1. No Grooves are visible, and this is a scuff caused by emergency steering and braking combined of a light vehicle. This is not the mark of a bus as initially perceived.

6.7.3 The mark did not have a fixed track distance. The outer tire to tire distance of the bus wheels are 2.48meters. These marks varied between 2.2 to 1.8 meters. This indicated that they were not marks of the same vehicle.

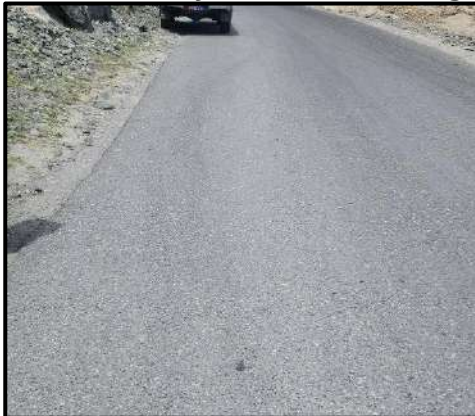
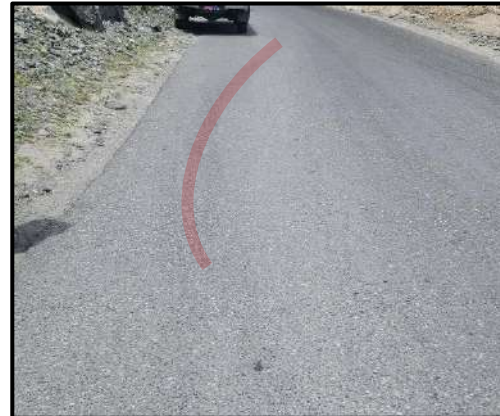
6.8.1 This mark was found on the incoming lane. It is observed to be scuff mark, not a steer mark.

6.8.2 With the close observation, it resembles to a scuff mark of a smaller LTV vehicle which has emergency braked at the crash site. It was not related to the crash.

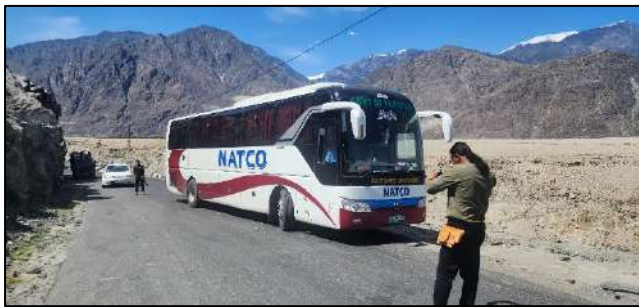
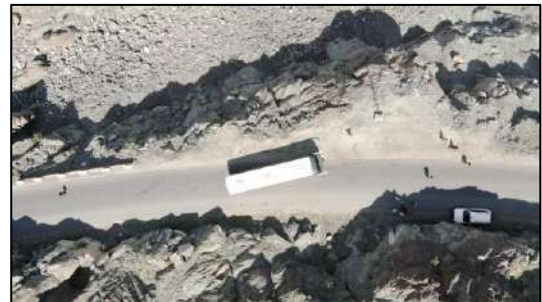
A small enactment was conducted to see if the observed skid marks were of the left or right wheels of the bus. The vehicle was placed in both possibilities (once with the left wheels on the marks and once with the right wheels on the marks) and photographed aerially.

7.1.1 (Likely Scenario) The skid marks were of the right side of the bus, the bus was approaching from the curve and went tangentially out due to misjudgement. It was early dawn, the traffic volume was very low and it was unlikely that the bus had to conduct an overtake maneuver.

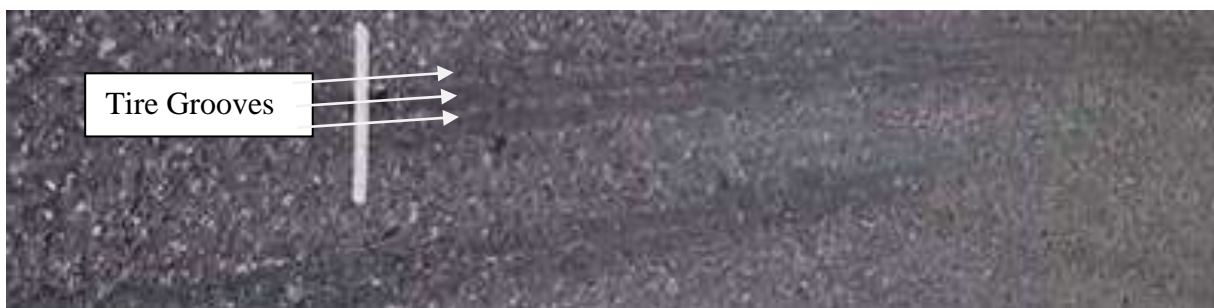
- 7.2.1. At the point when driver applied the brakes, the tire marks showed distinct tire grooves. This conclusively indicates that the steering wheel was pointing towards the ravine rather than the road.

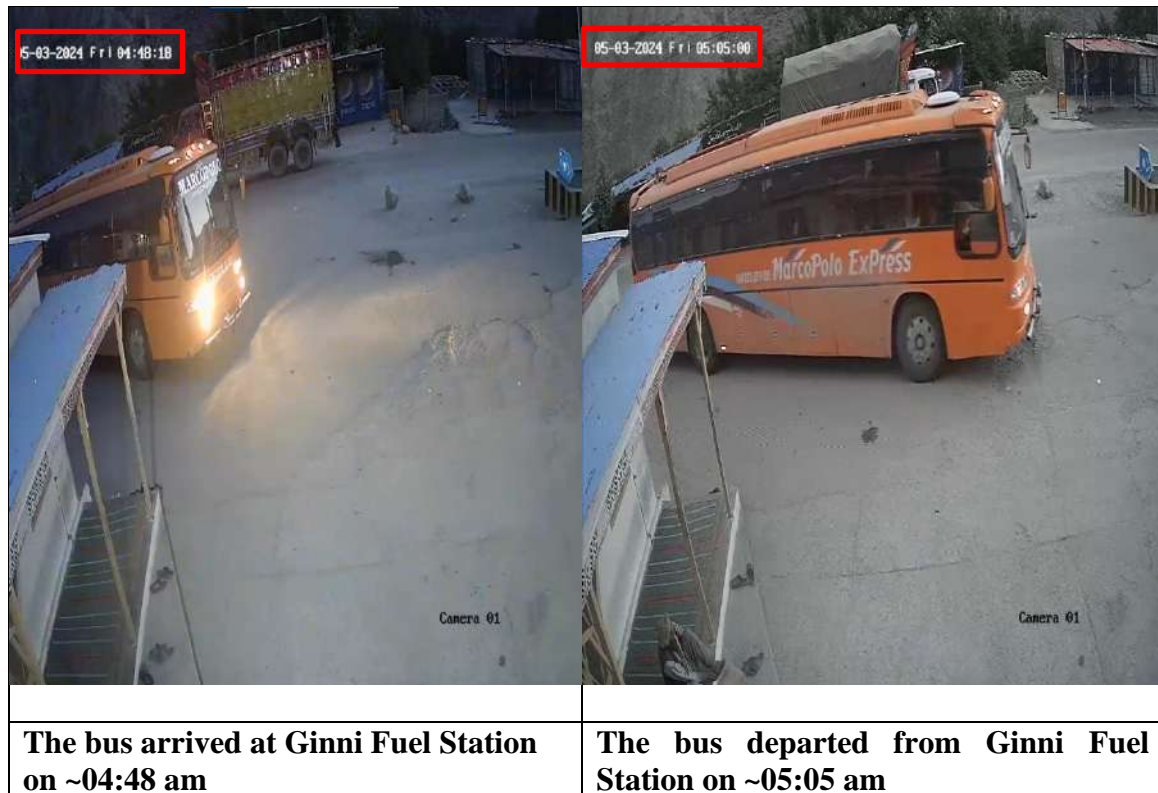
- 8.1 Recoding was taken from the CCTV camera footage of Ginni Fuel Station, Chillas was obtained and analysed.

- 8.2 The crash site is 10km ahead of the fuel station.
- 8.3 The driver remained on his seat and the bus was idling when the passengers were taking prayer break.
- 8.4 The least possible time was calculated by traversing on highest possible speed between two points was 9 minutes and 38 seconds which is unlikely to achieve by a full booked Bus.

- 8.5 The possible traversing time of the bus is 10:30 to 11 minutes between stopping and crashing point.
- 8.6 On close observations of the recording at Ginni Fuel Station, no other vehicle was observed crossing the pump station on the time between 05:10 am to 05:20 am neither from 05:30 am onwards.
- 8.7 A truck carrying gas cylinders arrived at the site at 5:21am; 16 minutes after the bus left. Since the travel time of the bus could not be less than 9 minutes 40 seconds and the travel time of the truck could not be less than 11 minutes, making a total of 21 minutes. This truck is not likely involved in the crash.
- 8.8 No other vehicle was observed coming south bound between the time period (5:25 am to 5:30 am). It is concluded that there was no other vehicle involved.

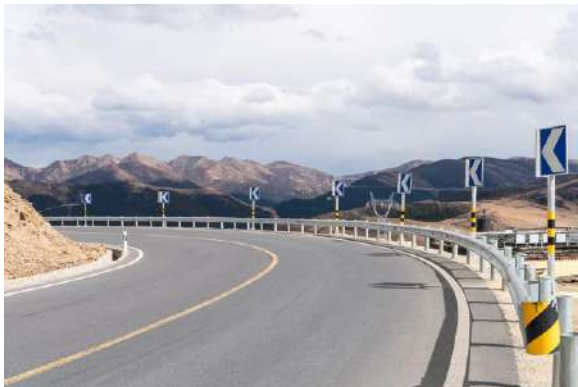
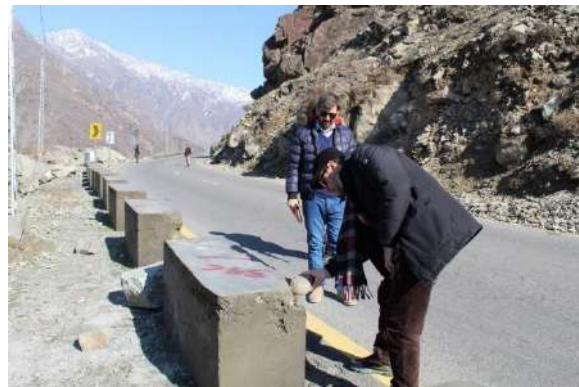
The issue of Substandard para pit walls and non-provision of guard rails must also formally be undertaken by the Government of Gilgit Baltistan with the federal Government of Pakistan. They should also conduct a formal road safety Audit of the Highways within GB.
